# Effect of Corrosion on Pushover Performance of a Steel Plate Shear Wall

**Abstract**— In some areas with the probability of chemical attacks such as near the sea or oil refinery, steel plate shear walls (SPSWs) may be affected by corrosion and after a while gets loss of efficiency. In present study, the effect of web plate corrosion on pushover behavior of a single SPSW is investigated. For this purpose, experimental tests were conducted on SPSW specimen whose web plate corroded according to ASTM B117 and also on uncorroded specimen for comparison. The specimens were subjected to pushover loading and performances of the SPSWs were evaluated. The results show that the corrosion has a significant effect on the behavior of the SPSWs such as initial stiffness and shear capacity.

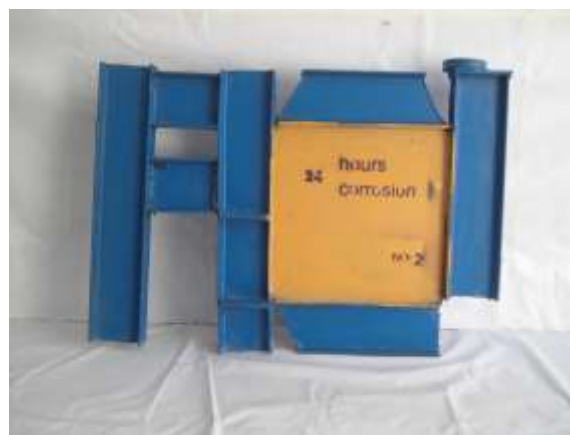
Figure 1. A typical specimen of single SPSW.

The test specimen, the test set up and the specimen dimensions is schematically shown in fig. 1 and fig. 2. In this work, for evaluation the relative corrosion the ASTM B117 [4] Salt Spray (Fog) test as accelerated tests is applied. In this test, the specimen is situated in an enclosed salt spray cabinet and subjected to an indirect spray of a neutral (pH 6.5-7.5) salt water solution.

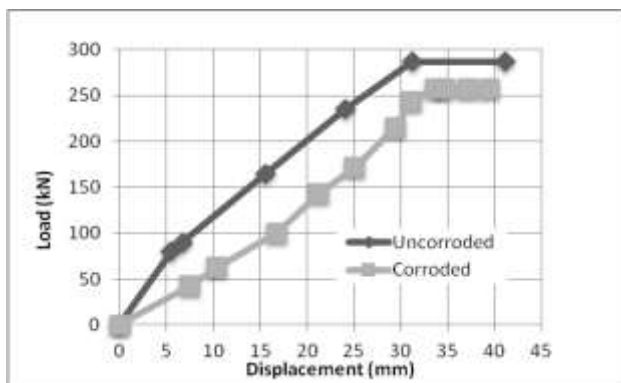
Load and displacement of the load application point were measured and plotted in fig. 3. As seen, the corrosion has a very significant effect on the initial stiffness of SPSW specimen; so that the specimen under corrosion loses about 60% of its initial stiffness. Also, as obtained from the experimental curve, the effect of corrosion on the shear capacity also is significant; so that

Figure 3. Load-displacement curves of the SPSW specimen.

the specimen under corrosion loses about 10% of their capacity.

Using table 2 and equation (1), the theoretical shear capacities could be calculated. As seen, reduction of the plate thickness due to the effect of corrosion has negligible effect on calculated shear capacity, while the experimental results for shear capacity show a significant decreasing due to the effect of corrosion. Hence, it seems that what causes the significant effect on the shear capacity is the change in material properties at the outside surfaces of plate due to the effect of corrosion rather than decreasing of the thicknesses.

1- Corrosion has a very significant effect on the initial stiffness of SPSW specimen; so that the specimen under corrosion loses about 60% of their initial stiffness.

2- Corrosion has a significant effect on the shear capacity of SPSW specimen; so that the specimen under corrosion loses about 10% of its capacity.
